Recovery Furnace Floor Design and Alternative Materials

J. L. Clement
Marketing Manager
Babcock & Wilcox
Barberton, Ohio, U.S.A.

Presented to:
Tenth Latin American Recovery Congress
August 26-30, 1996
Concepcion, Chile

BR-1619

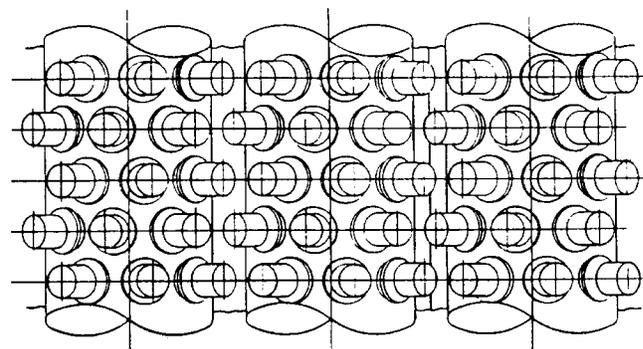
Figure 2 High density pin stud protection.

The dense pattern of pin studs applied on the carbon steel tube is illustrated in Figure 2. Pin studs are 25.4 mm (1 in.) length by 12.7 mm (0.5 in.) diameter and are resistance welded to the tube to achieve a density of 1980 studs/m² on membrane panels fabricated with 62.4 mm (2.5 in.) outside diameter tubes. Experience has shown that any lesser diameter or density does not provide long term corrosion protection of the tube.^[1] The pin studs retain refractory or frozen smelt to provide a barrier between the molten smelt and the tube. Exposure of the carbon steel tube to a flow of molten smelt could have the effect of removing the tube wall metal.

The failures in carbon steel floor tubes that have pin studs are characterized by stud wastage, or burn-back, and thinning of the tube wall. In all cases of either failure, or discovery of a floor area that had been subjected to metal loss but not failed, the stud wastage that reduces the tube protection was in small, localized areas. Metallurgical examination determined that the tube in the failure area had been subjected to a high metal temperature in the range of 700 to 800 C (1300 to 1500 F). The conclusion reached from all of the evidence was that the failures or loss of metal were due to corrosion of the tube as a result of liquid smelt contact with the tube at a high metal temperature.

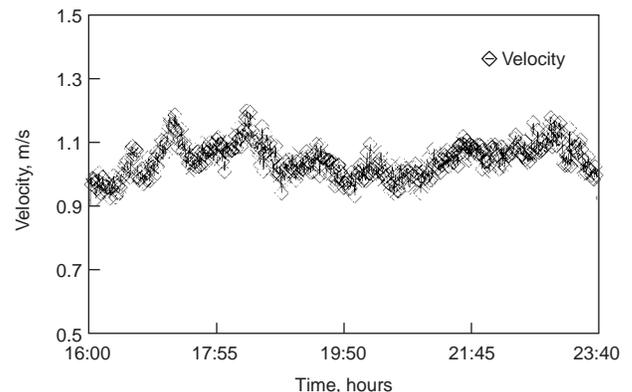
Figure 5 Floor tube velocity measurement.

for every recovery boiler operating with a superheater outlet pressure of 8.38 MPa (1200 psig) or above. Further steps were taken to install chordal thermocouples and pitot tubes in selected recovery furnace floor tubes. Figure 4 shows a typical chordal thermocouple tube. The investigation resulted in the conclusion that circulation was not the cause of the problem. Measured floor tube velocities were as predicted. Figure 5 shows velocity data from one of the furnaces investigated.

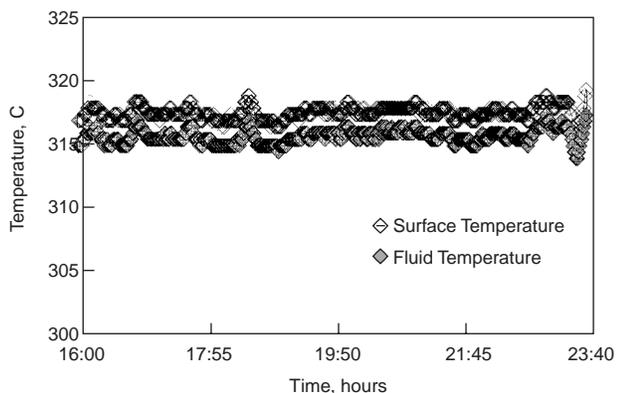
Figure 6 Floor tube temperature measurement.

Chordal thermocouples have been installed in five (5) recovery boilers and extensive temperature data recorded for each. In four (4) of the furnaces, the chordal sections were installed in the carbon steel, pin stud section of the floor, and in two (2) of the furnaces, two (2) chordal sections were installed in the composite tube sections. Figure 6 is an example of typical data. The data showed no transient surface temperature under any significant operating condition, including start-up, shutdown, boiler trip and steady state. Temperatures were substantially below those evidenced by metallurgical examination of failed tubes. There was no recorded evidence of steam blanketing of the tube waterside under any operating condition, including start-up and burning auxiliary fuel with no bed in the furnace. The chordal thermocouples showed very low heat input to the floor when covered with the char bed. Heat fluxes were determined to be in the expected range.

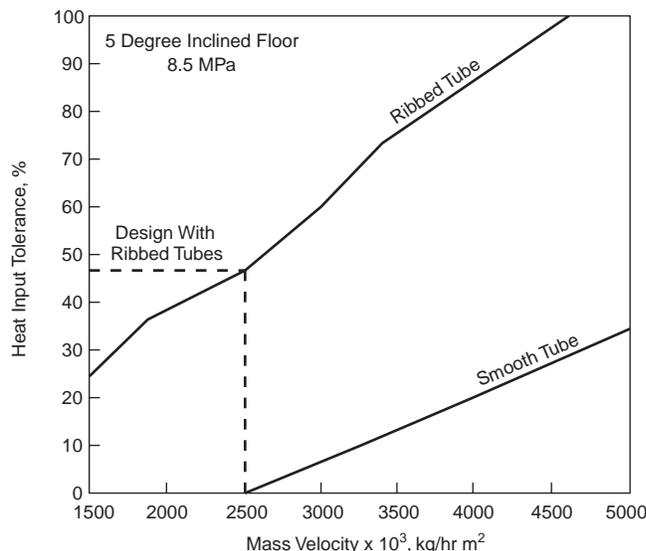
Figure 8 Margin for heat input transient.

The tubes in several pin stud recovery floors have been replaced using Multiple Lead Ribbed (MLR) tubes in the place of smooth bore tubes. MLR tubes (Figure 7) have helical ribs on the inside surface of the tube.^[4] The ribs generate a swirl flow resulting in a centrifugal action which forces the water to the tube wall and retards steam blanketing. The MLR tube increases the tolerance for higher heat input transients that may occur. In one case, the recovery boiler was being upgraded in capacity and the application of the MLR tubes in the floor was the economical alternative to installing additional riser circuit tubes between the upper wall headers and the steam drum. Figure 8 shows a typical example of MLR tubes installed in a recovery boiler operating at 8.5 MPa where the circulation margin for heat flux was increased by a factor of about 50%.

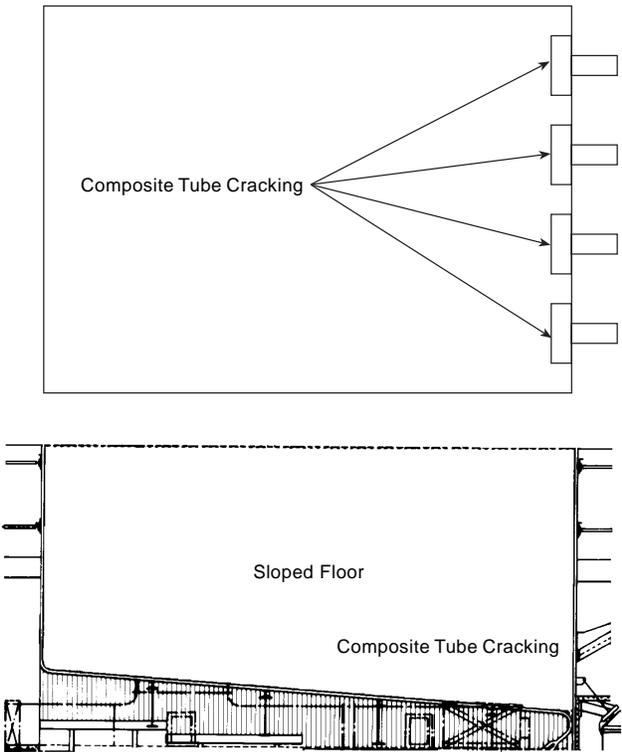
Figure 9 Zones of cracking – Babcock & Wilcox.

Figure 9 illustrates a Babcock & Wilcox lower furnace with the standard inclined, fully drainable floor. The most prevalent area of cracking is in the smelt spout openings and/or the wall tubes adjacent to the openings. There have also been incidents of cracks in the floor, including one unit placed in-service in 1982, where a high incidence of cracks has resulted in the floor being replaced during 1996 after 14 years of operation. There are 52 operating recovery boilers where Babcock & Wilcox has installed composite furnaces. The floor construction in these units can be summarized as follows:

The work of Klarin provides an explanation for the floor tube cracking.^[3] For the cracking in the wall tubes, it is possible to visualize that the surface of the pool of smelt rises and falls during operation to cause temperature fluctuations in the tube and thereby induce thermal fatigue cracking.

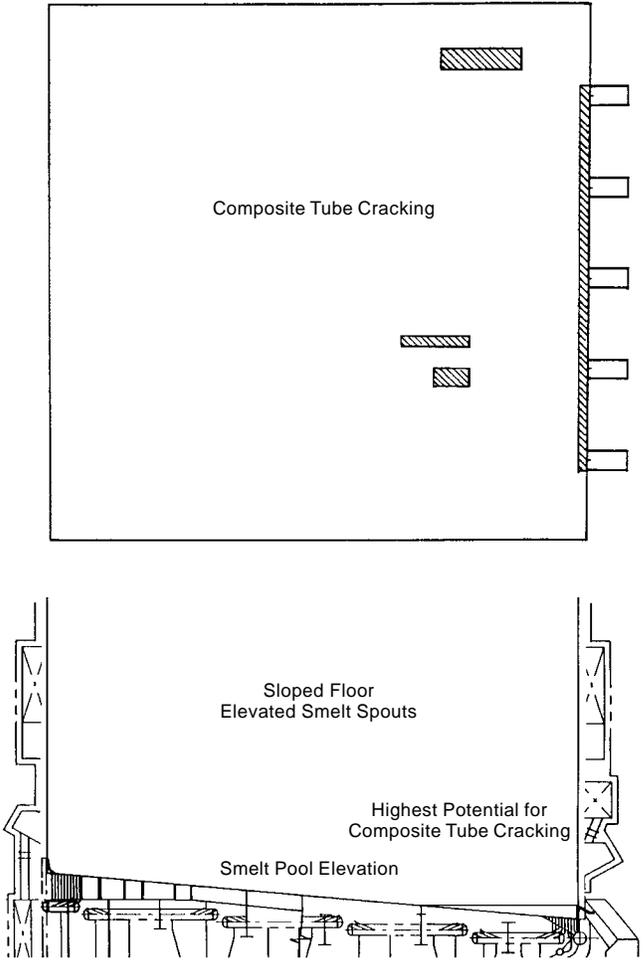
Figure 10 Zones of cracking – supplier A.

The Supplier B recovery furnace uses an inclined floor with raised smelt spouts and is designated as “semi-drainable.” Figure 10 illustrates the areas of cracking to be most severe under the pool of smelt formed by the raised spouts. Cracking occurs at the spout openings and adjacent tubes similar to that shown in Figure 9, but also at the interface between the surface of the pool and the side wall tubes.

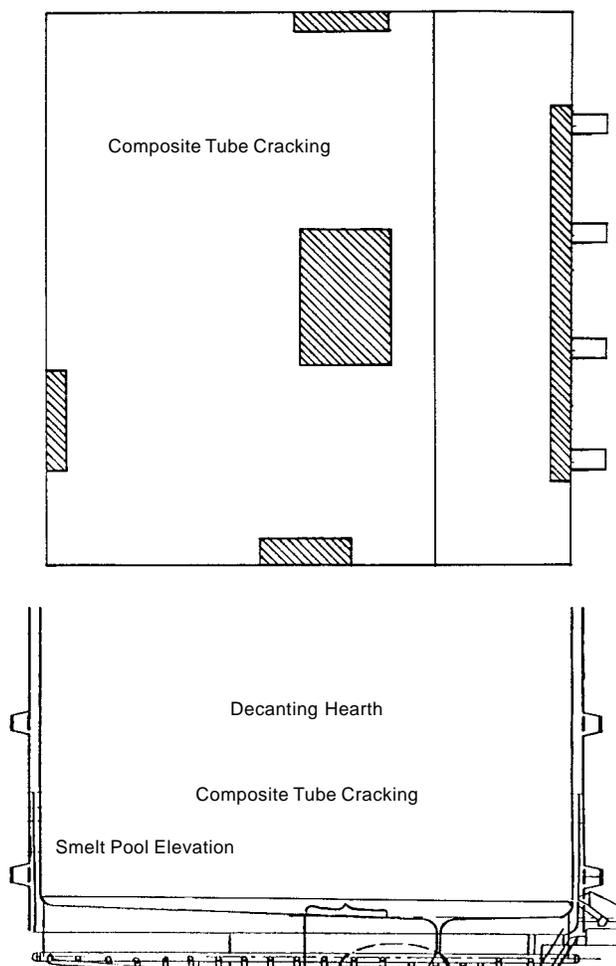
Figure 11 Zones of cracking – supplier B.

The decanting hearth design is used by several manufacturers of recovery boilers. Those cases in the USA where cracking is known to have occurred have composite tube floors and show a pattern of cracks for Supplier C illustrated by Figure 11. Cracking has been found in the floor and at the interface between the surface of the smelt pool and the wall tubes.

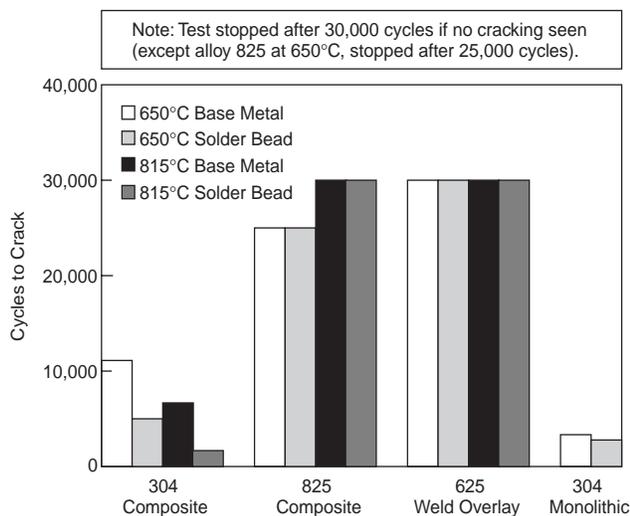
Figure 14 Thermal fatigue cycling tests.

The results of the testing are presented in Figure 14. The sharp contrast is obvious between the life of the tubes with TP304L material and the nickel alloy tubes. Testing was arbitrarily stopped at 30,000 cycles to remove the test samples for metallurgical examination. There was no evidence of cracking of the 825 or 625 material. The Thermal Fatigue Cycling tests support the possibility of the nickel alloy tubes being superior for reduced cracking of the clad layer in the recovery furnace environment. Development of the Sanicro 38/4L7 material, similar to the 825 material, is summarized by Sandvik.^[6]
