METSERVE INTERNATIONAL

METALLURGICAL CONSULTANCY

Finding the Root Cause is Critical

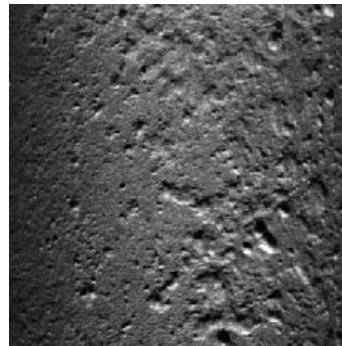
Oxygen Pitting

Symptoms: Aggressive localized corrosion and loss of tube wall, most prevalent near economizer feedwater inlet on operating boilers. Flooded or non-drainable surfaces are most susceptible during outage periods.

Causes: Oxygen pitting occurs with the presence of excessive oxygen in boiler water. It can occur during operation as a result of in-leakage of air at pumps, or failure in operation of preboiler water treatment equipment. This also may occur during extended out-of-service periods, such as outages and storage, if proper procedures are not followed in lay-up. Non-drainable locations of boiler circuits, such as superheater loops, sagging horizontal superheater and reheater tubes, and supply lines, are especially susceptible.

◀ Oxygen pitting on tube ID

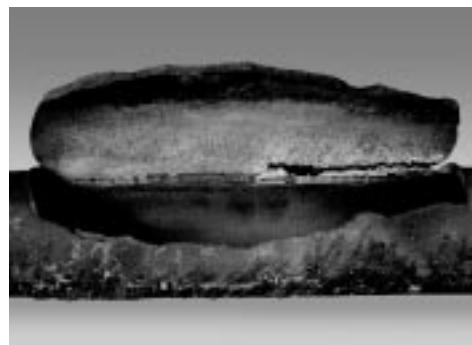
Hydrogen Damage

Symptoms: Intergranular micro-cracking. Loss of ductility or embrittlement of the tube material leading to brittle catastrophic rupture.

Causes: Hydrogen damage is most commonly associated with excessive deposition on ID tube surfaces, coupled with a boiler water low pH excursion. Water chemistry is upset, such as what can occur from condenser leaks, particularly with salt water cooling medium, and leads to acidic (low pH) contaminants that can be concentrated in the deposit.

Under-deposit corrosion releases atomic hydrogen which migrates into the tube wall metal, reacts with carbon in the steel (decarburization) and causes intergranular separation.

▲ Brittle failure due to hydrogen damage

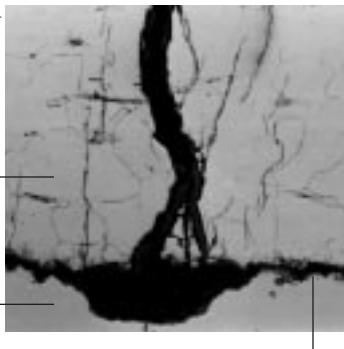
SEM photo of stress corrosion cracking

Stress Corrosion Cracking (SCC)

Symptoms: Failures from SCC are characterized by a thick wall, brittle-type crack. May be found at locations of higher external stresses, such as near attachments.

Causes: SCC most commonly is associated with austenitic (stainless steel) superheater materials and can lead to either transgranular or intergranular crack propagation in the tube wall. It occurs where a combination of high-tensile stresses and a corrosive fluid are present. The damage results from cracks that propagate from the ID. The source of corrosive fluid may be carryover into the superheater from the steam drum or from contamination during boiler acid cleaning if the superheater is not properly protected.

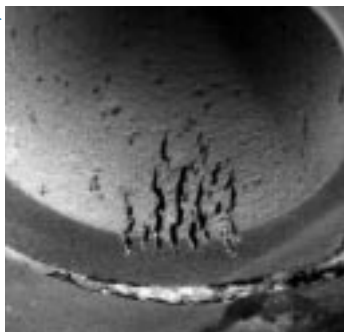
Corrosion fatigue on tube ID adjacent to attachment

Waterside Corrosion Fatigue

Symptoms: ID initiated, wide transgranular cracks which typically occur adjacent to external attachments.

Causes: Tube damage occurs due to the combination of thermal fatigue and corrosion. Corrosion fatigue is influenced by boiler design, water chemistry, boiler water oxygen content and boiler operation. A combination of these effects leads to the breakdown of the protective magnetite on the ID surface of the boiler tube. The loss of this protective scale exposes tube to corrosion. The locations of attachments and external weldments, such as buckstay attachments, seal plates and scallop bars, are most susceptible. The problem is most likely to progress during boiler start-up cycles.

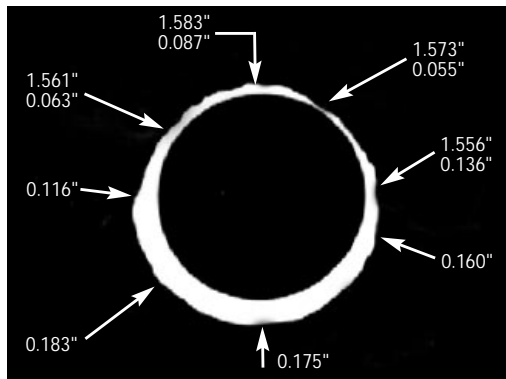
Superheater Fireside Ash Corrosion

Symptoms: External tube wall loss and increasing tube strain. Tubes commonly have a pock-marked appearance when scale and corrosion products are removed.

Causes: Fireside ash corrosion is a function of the ash characteristics of the fuel and boiler design. It usually is associated with coal firing, but also can occur for certain types of oil firing. Ash characteristics are considered in the boiler design when establishing the size, geometry and materials used in the boiler. Combustion gas and metal temperatures in the convection passes are important considerations. Damage occurs when certain coal ash constituents remain in a molten state on the superheater tube surfaces. This molten ash can be highly corrosive.

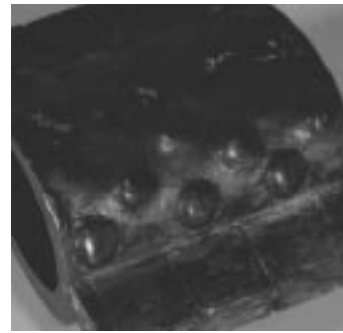
Waterwall Fireside Corrosion

Symptoms: External tube metal loss (wastage) leading to thinning and increasing tube strain.

Causes: Corrosion occurs on external surfaces of waterwall tubes when the combustion process produces a reducing atmosphere (substoichiometric). This is common in the lower furnace of process recovery boilers in the pulp and paper industry. For conventional fossil fuel boilers, corrosion in the burner zone usually is associated with coal firing. Boilers having maladjusted burners or operating with staged air zones to control combustion can be more susceptible to larger local regions possessing a reducing atmosphere, resulting in increased corrosion rates.

◀ Fireside corrosion of studded tube

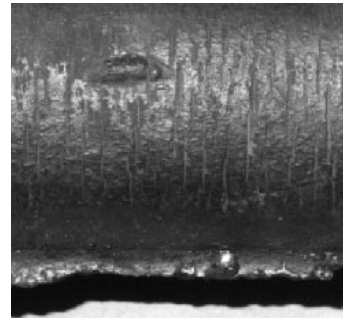
Fireside Corrosion Fatigue

Symptoms: Tubes develop a series of cracks that initiate on the outside diameter (OD) surface and propagate into the tube wall. Since the damage develops over longer periods, tube surfaces tend to develop appearances described as “elephant hide,” “alligator hide” or craze cracking. Most commonly seen as a series of circumferential cracks. Usually found on furnace wall tubes of coal-fired once-through boiler designs, but also has occurred on tubes in drum-type boilers.

Causes: Damage initiation and propagation result from corrosion in combination with thermal fatigue. Tube OD surfaces experience thermal fatigue stress cycles which can occur from normal shedding of slag, sootblowing or from cyclic operation of the boiler. Thermal cycling, in addition to subjecting the material to cyclic stress, can initiate cracking of the less elastic external tube scales and expose the tube base material to repeated corrosion.

◀ Craze cracking of OD surface

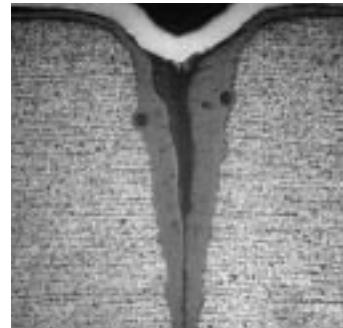
◀ Transverse view of surface crack

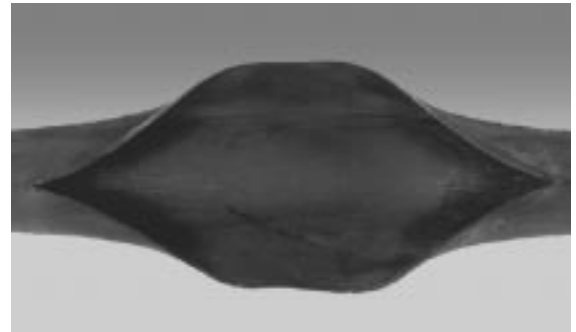
Short-term Overheat

Symptoms: Failure results in a ductile rupture of the tube metal and is normally characterized by the classic “fish mouth” opening in the tube where the fracture surface is a thin edge.

Causes: Short-term overheat failures are most common during boiler start up. Failures result when the tube metal temperature is extremely elevated from a lack of cooling steam or water flow. A typical example is when superheater tubes have not cleared of condensation during boiler start-up, obstructing steam flow. Tube metal temperatures reach combustion gas temperatures of 1600°F or greater which lead to tube failure.

▲ Thin-edged “fish mouth” rupture

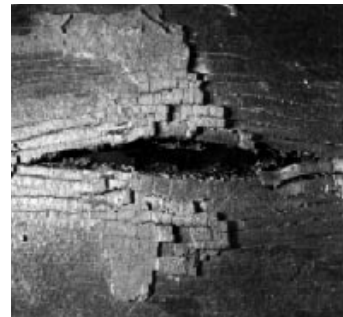
Long-term Overheat

Symptoms: The failed tube has minimal swelling and a longitudinal split that is narrow when compared to short-term overheat. Tube metal often has heavy external scale build-up and secondary cracking.

Causes: Long-term overheat occurs over a period of months or years. Superheater and reheat superheater tubes commonly fail after many years of service, as a result of creep. During normal operation, alloy superheater tubes will experience increasing temperature and strain over the life of the tube until the creep life is expended. Furnace water wall tubes also can fail from long-term overheat. In the case of water wall tubes, the tube temperature increases abnormally, most commonly from waterside problems such as deposits, scale or restricted flow. In the case of either superheater or water wall tubes, eventual failure is by creep rupture.

◀ View of tube OD at failure (creep failure)

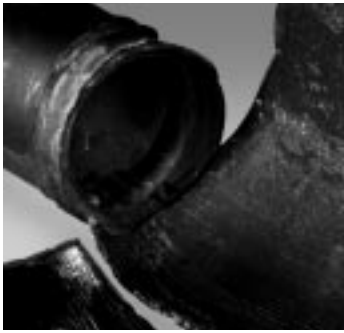
Failure of carbon steel tube at butt weld

Graphitization

Symptoms: Failure is brittle with a thick edge fracture.

Causes: Long-term operation at relatively high metal temperatures can result in damage in carbon steels of higher carbon content, or carbon-molybdenum steel, and result in a unique degradation of the material in a manner referred to as graphitization. These materials, if exposed to excessive temperature, will experience dissolution of the iron carbide in the steel and formation of graphite nodules, resulting in a loss of strength and eventual failure.

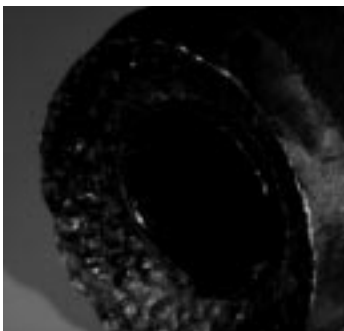
DMW failure where ferritic material has completely separated, leaving the DMW

Dissimilar Metal Weld (DMW) Failure

Symptoms: Failure is preceded by little or no warning of tube degradation. Material fails at the ferritic side of the weld, along the weld fusion line. A failure tends to be catastrophic in that the entire tube will fail across the circumference of the tube section.

Causes: DMW describes the butt weld where an austenitic (stainless steel) material joins a ferritic alloy, such as SA213T22, material. Failures at DMW locations occur on the ferritic side of the butt weld. These failures are attributed to several factors: high stresses at the austenitic to ferritic interface due to differences in expansion properties of the two materials, excessive external loading stresses and thermal cycling, and creep of the ferritic material. As a consequence, failures are a function of operating temperatures and unit design.

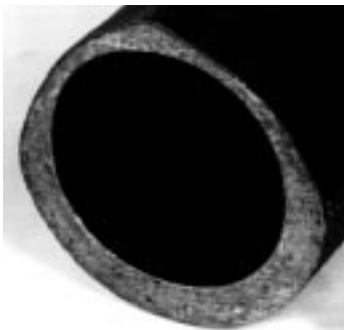
Erosion on tube OD

Erosion

Symptoms: Tube experiences metal loss from the OD of the tube. Damage will be oriented on the impact side of the tube. Ultimate failure results from rupture due to increasing strain as tube material erodes away.

Causes: Erosion of tube surfaces occurs from impingement on the external surfaces. The erosion medium can be any abrasive in the combustion gas flow stream, but most commonly is associated with impingement of fly ash or soot blowing steam. In cases where soot blower steam is the primary cause, the erosion may be accompanied by thermal fatigue.

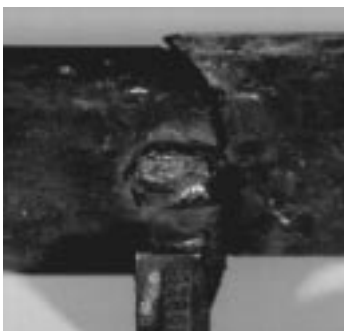
Mechanical fatigue failure at an attachment

Mechanical Fatigue

Symptoms: Damage most often results in an OD initiated crack. Tends to be localized to the area of high stress or constraint.

Causes: Fatigue is the result of cyclical stresses in the component. Distinct from thermal fatigue effects, mechanical fatigue damage is associated with externally applied stresses. Stresses may be associated with vibration due to flue gas flow or sootblowers (high-frequency low-amplitude stresses), or they may be associated with boiler cycling (low-frequency high-amplitude stress mechanism). Fatigue failure most often occurs at areas of constraint, such as tube penetrations, welds, attachments or supports.
