# Babcock & Wilcox

## Condition Assessment Services

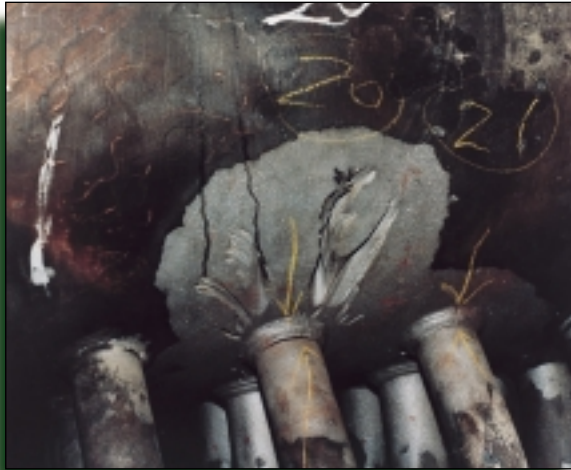
Figure 1: Photo of header where metal was removed by the washing action of steam leaks — a result of undetected ligament cracks.

High temperature superheater and reheater headers that operate at temperatures above 900°F (482°C) are subject to long term damage due to creep and creep-fatigue. Your predictive maintenance programs must include these high temperature headers. Otherwise, your first indication of problems could be tube stub weld leaks (figure 1). Babcock & Wilcox (B&W) has been a leader in the assessment of superheater and reheater headers since the problems of ligament cracking first appeared in the early 1980s. We have assessed the condition of hundreds of high temperature headers —many nearing the end of useful life.

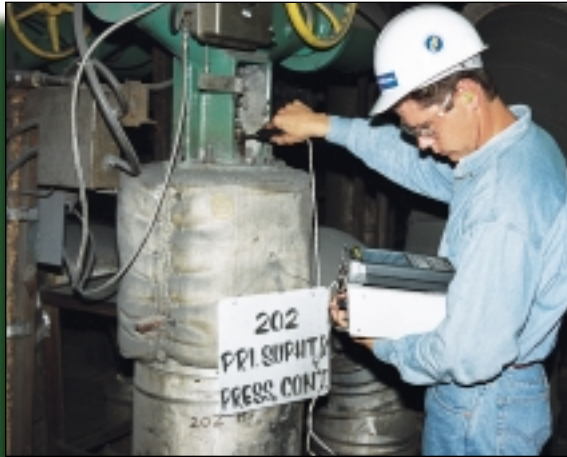
Figure 11: B&W's valve testing service can quickly detect even the slightest seat leakage with high accuracy.

Both industrial and utility plants have hundreds of valves that must be maintained or periodically replaced. Valve maintenance can be costly. However, lack of valve maintenance can be just as costly because of lost heat and efficiency. B&W offers a cost effective **Valve Leak Detection** service that optimizes your valve maintenance program. You can avoid maintenance to valves that are not leaking, and more importantly, you will know which valves to replace first based on the severity of the leaks. Our valve leak detection service uses a portable test instrument so that testing is fast — more than 50 valves can be tested in a single shift (figure 11). Our test only requires access to the valve stem, so expensive insulation removal is not needed. And since we have tested over 5,000 valves, the test has a proven record of accuracy and reliability. For more information on B&W's valve leak detection, ask for PS-360.

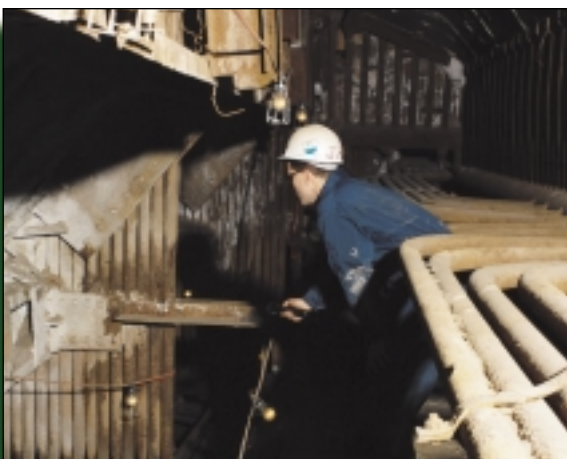
Figure 13: Boiler fitness surveys include a thorough inspection of your boiler to identify opportunities for improved performance.

Drawing on the experience of our field engineers (figure 13), B&W provides a complete assessment of the entire boiler in the boiler fitness survey. We work with you to determine the critical components in your boiler and tailor an assessment program to your needs. Since we have performed surveys on boilers throughout the world, we have the knowledge to help you plan your testing and inspections for the most cost effective program.

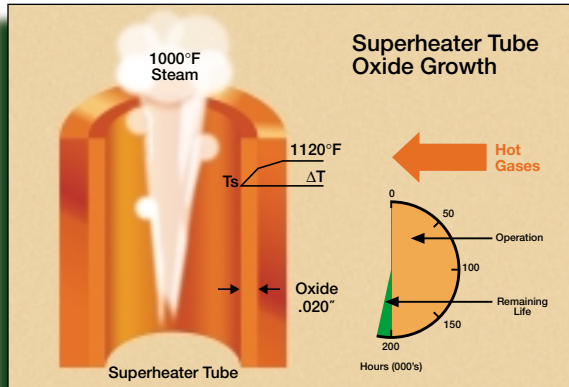
Figure 7: Steam side oxide scale on tube ID increases tube metal temperature and reduces tube life.

Just as with high temperature headers and piping systems, alloy tubing in the superheater and reheater experience creep during normal long term operation which eventually leads to creep-rupture failure. Oxide scale builds up on the inside diameter (ID) surface and has an insulating effect raising tube temperatures (figure 7). At the same time, tubes can experience wall loss from corrosion and erosion leading to increased tube stresses.

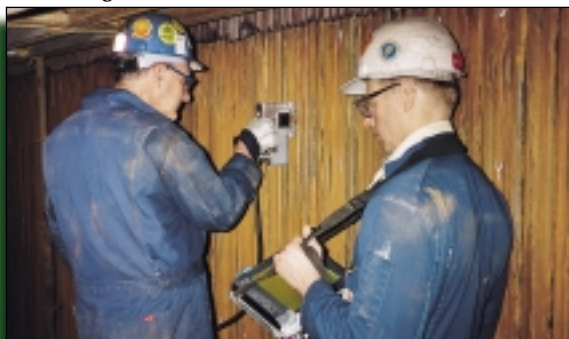
Figure 9: The exceptional testing speed of the FST-GAGE™ allows B&W technicians to scan thousands of feet of boiler tubing.

More recently, working with the Electric Power Research Institute, we developed a new test based on electromagnetic acoustic transducer technology called the FST-GAGE™. Our FST-GAGE test scans tubes to find corrosion or hydrogen damage many times faster than UT based tests (figure 9). Corrosion fatigue, another “hidden” problem attributed to corrosion in combination with thermal cycling, also can be found in many older boilers (figure 10). More recently we have developed special probes for the FST-GAGE test which can detect certain types of corrosion fatigue damage. For a more detailed discussion of tube failure mechanisms, ask for E101-3153. For information on the B&W FST-GAGE™ test service, ask for PS-368.

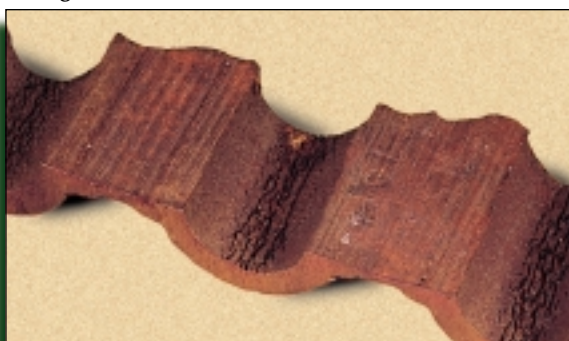
Figure 10: Corrosion fatigue cracks in membraned wall tubes.
