METSERVE INTERNATIONAL

METALLURGICAL CONSULTANCY

Finding the Root Cause is Critical

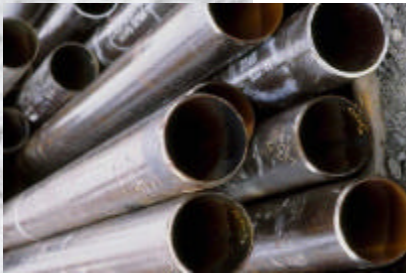
Corrosion fatigue on tube ID adjacent to attachment

Symptoms: ID initiated, wide transgranular cracks which typically occur adjacent to external attachments.
