Recovery Furnace Floor Design and Alternative Materials

J. L. Clement
Marketing Manager
Babcock & Wilcox
Barberton, Ohio, U.S.A.

Presented to:
Tenth Latin American Recovery Congress
August 26-30, 1996
Concepcion, Chile

BR-1619

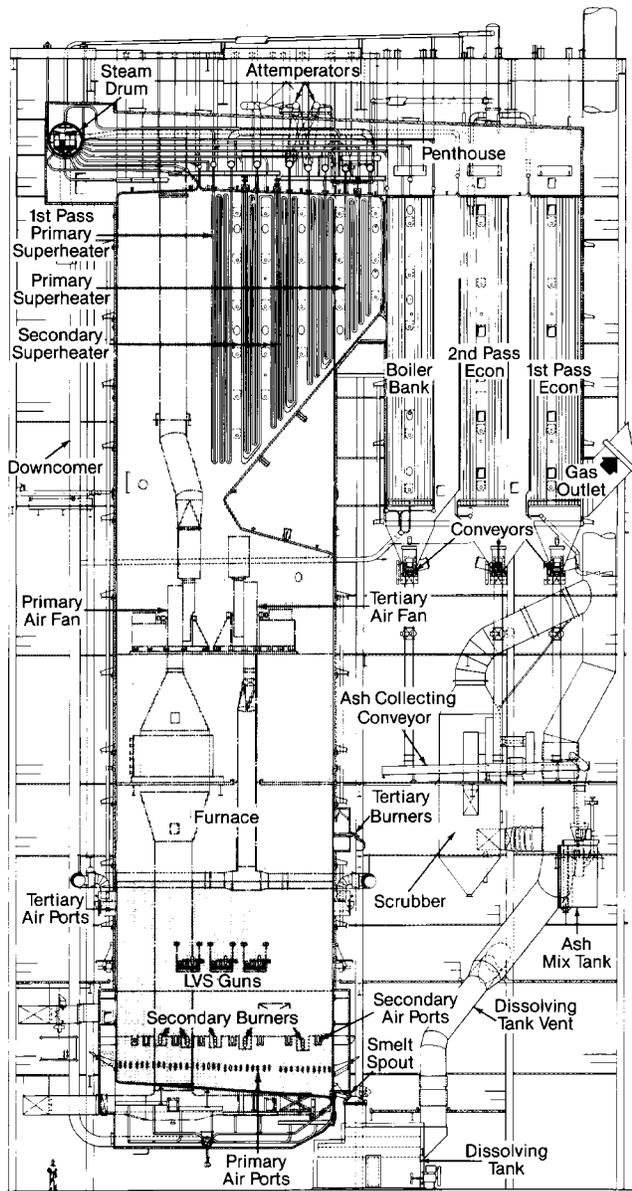
Figure 3 Typical modern recovery boiler.

There are 22 composite tube recovery furnaces that have been built with this construction for the central section of the floor. Figure 3 shows a typical modern recovery boiler operating in

the southeastern USA.^[2] There have been four (4) incidents of base tube wall metal loss, three (3) with failure of the tube. These, and two (2) other failure incidents in boilers with a decanting style floor, are summarized in Table 1. The Babcock & Wilcox boilers are designed with positive inclination floor tubes for positive circulation, whereas the floor in Supplier A's furnaces is flat for the decanting hearth design.

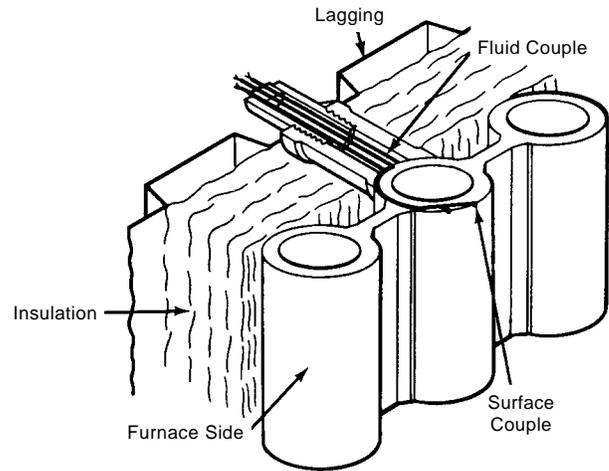
Figure 4 Chordal thermocouple.

for every recovery boiler operating with a superheater outlet pressure of 8.38 MPa (1200 psig) or above. Further steps were taken to install chordal thermocouples and pitot tubes in selected recovery furnace floor tubes. Figure 4 shows a typical chordal thermocouple tube. The investigation resulted in the conclusion that circulation was not the cause of the problem. Measured floor tube velocities were as predicted. Figure 5 shows velocity data from one of the furnaces investigated.

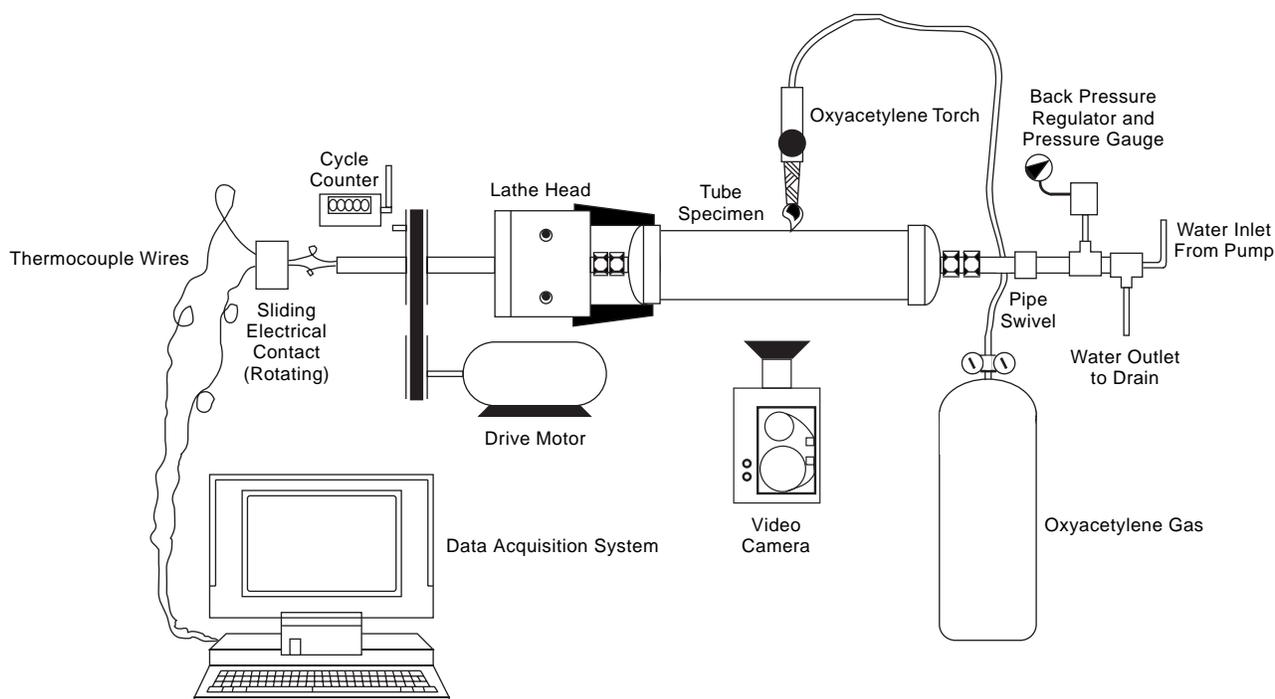
Figure 12 Thermal fatigue test facility.

The base tube material for the first three of the above is SA-210 Grade A1 carbon steel. The thermal fatigue testing was conducted at the Company's Research Center in Alliance, Ohio. Figure 12 is a schematic illustration of the test facility in which the water cooled tube is rotated to affect a rapid change in temperature of the tube wall from the controlled temperature at the point of flame impingement to a low of about 40 C (104 F). Figure 13 describes in more detail the location of thermocouples to measure the inside surface temperature and the temperature of the clad layer. Cyclic testing was conducted at both 650 C and 814 C (1200 F and 1500 F); the testing at the higher temperature was initiated when cracking of the 825 and 625 clad material was not observed at 650 C.
